CAPSULE  
BUCKINGHAM

PRELIMINARY REPORT  
MARYLAND HISTORICAL TRUST

INVENTORY FORM FOR STATE HISTORIC SITES SURVEY

Buckingham

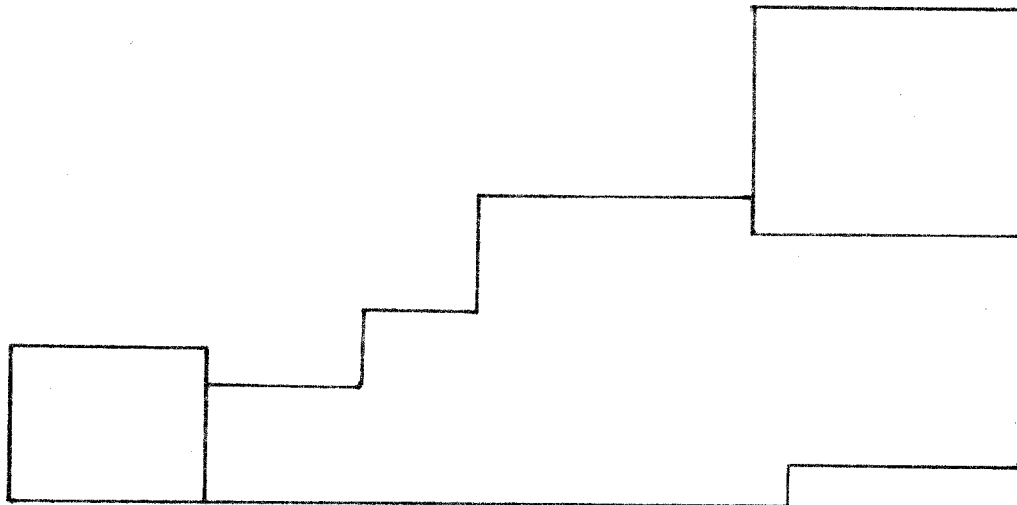
BUCKINGHAM  
FLOOR PLAN

This central portion of the house speaks strongly of the Federal period as can be seen on the outside by its tall tripartite massing. It is a stone building two stories high with a finished attic. It is three bays wide and two long bays deep. The plan is the typical side hall and double parlor plan with each of the parlors being served by interior end chimneys on the west end of the house. A gable end roof caps the structure. A pair of centralized pedimented dormers vent each side of the roof. The fenestration of the north and south facades is regular on the first two stories consisting of 6/6 sash. Bubbled glass is occasionally seen. There are two symmetrically placed basement windows on the north side and a single centrally placed window on the south.

At an early point in its history the central block was extended to the West by a stone addition of like construction that nearly doubled the size of the house. Both sections employ random size fieldstones that are coursed. Although not as tall as the original portion, the west wing is a full two stories and while it is also three bays wide, it is of shorter depth. The wing butts up against the main block and is absent of its own east wall. The 1930's blueprints and structural evidence shows that the present entrance in the westernmost bay of the south

Buckingham has had at least two interior renovations in this century and may well have had at least one during the Victorian era. Nevertheless a good deal of original fabric may still be seen. This description points out what may be seen at each level of the two oldest portions of the house ie. the central block and west wing. It is the conclusion of the report that they are close in age.

In the area beneath the central block one can see the typical framing of a side hall and parlor with transverse joists beneath the parlors and shorter longitudinal joists supporting the hall. These joists obviously meet at right angles to the easternmost parlor joist and are joined to it by mortise-tenon-and-trunnel. In both sections of the basement the floor framing is a mixture of hewn and vertical machine sawn lumber. Some pieces appear hewn on one side and sawn on the other. Joists average  $9\frac{1}{2}$ " x  $2\frac{3}{4}$ ".

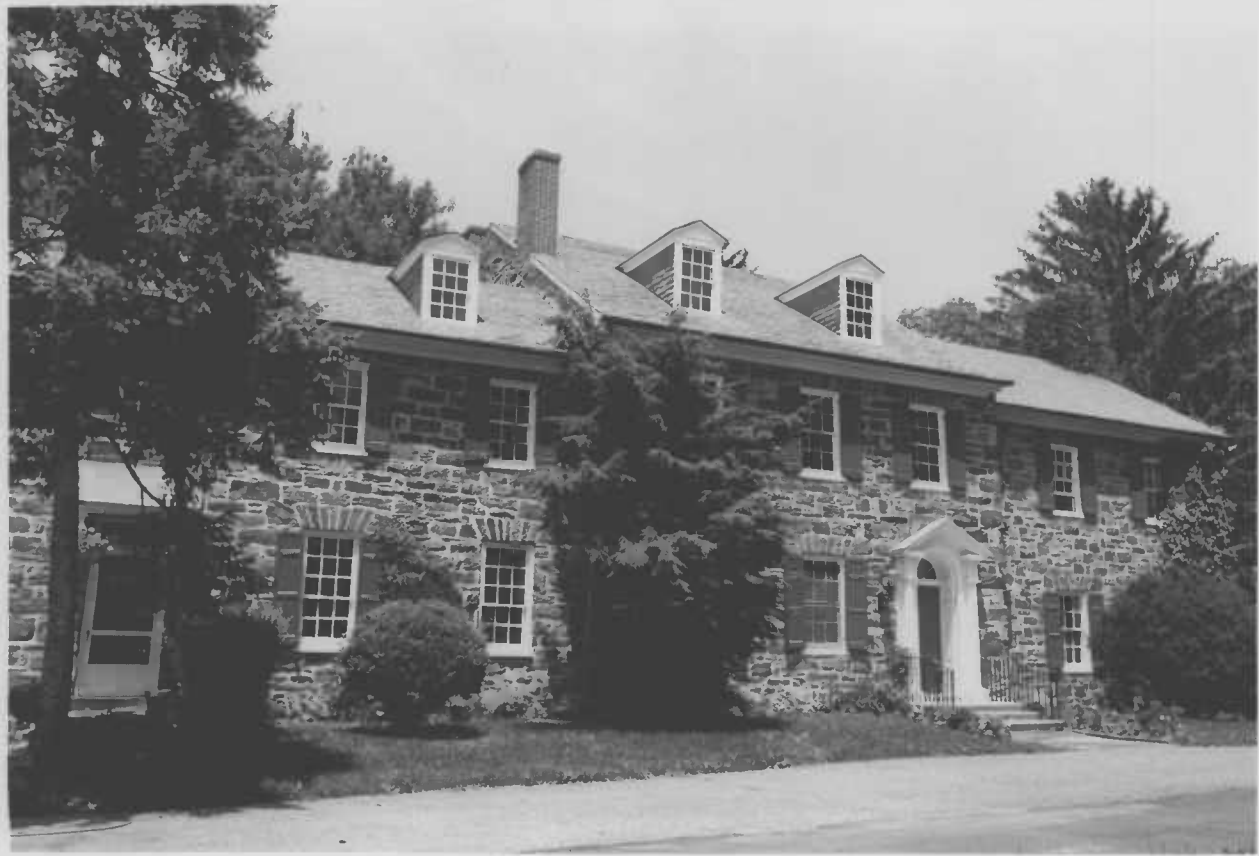
BUCKINGHAM  
S. FACADE

The elaborate pedimented doorway of the south facade is part of the 1930's renovation.

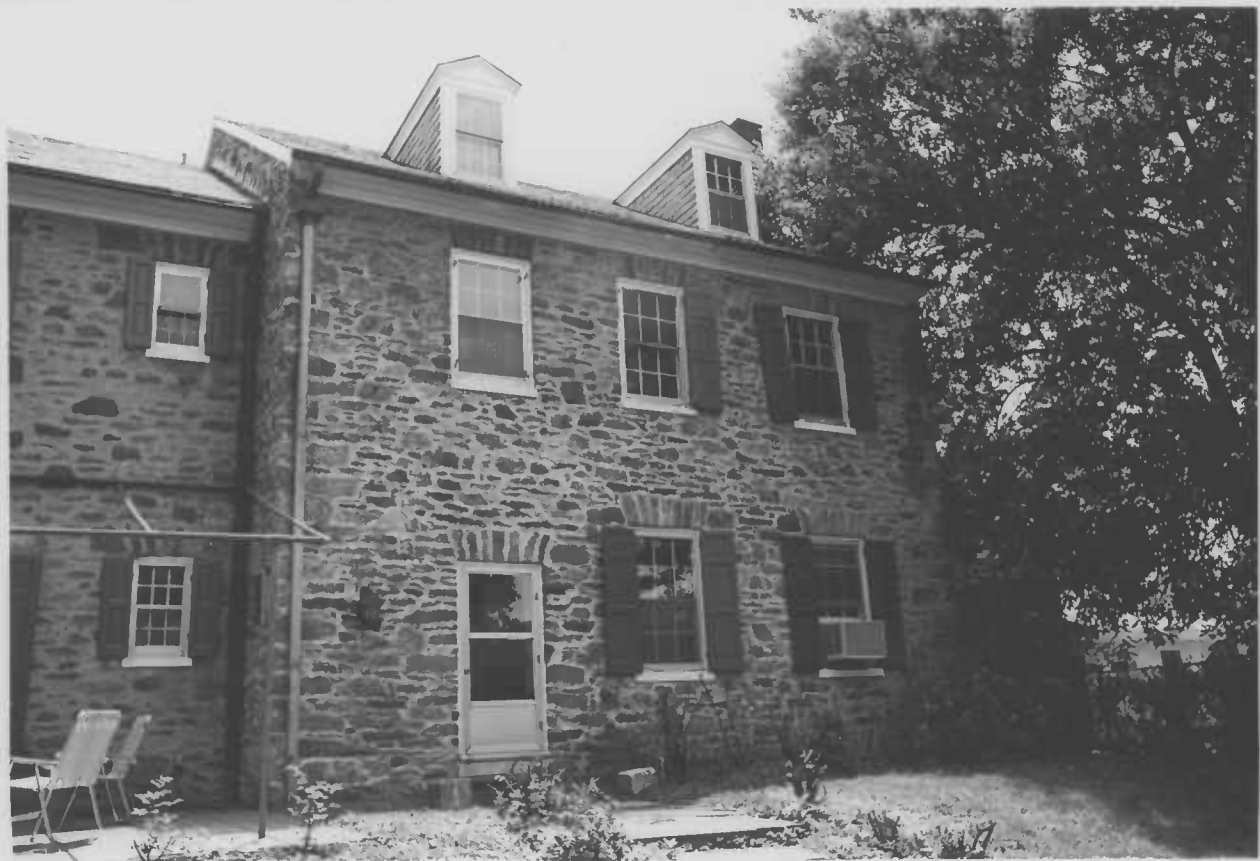
BUCKINGHAM  
N. FACADE

The west wing has a single interior end chimney with a brick cap on its west end. The gable end roof has pedimented dormers, however, they are of a slightly different motif than the main block. The north dormers of the main block and the south dormers of the west wing match but the south dormers of the main section have a simple block bisecting the lower portion of the pediment.
